DEPARTMENT OF TRANSPORTATION

Contract #: 04-0120F4Cty: SF/ALA Rte: 80 PM: 13.2/13.9File #: 69.28**WELDING INSPECTION REPORT****Resident Engineer:**Siegenthaler, Peter**Address:** 333 Burma Road**City:** Oakland, CA 94607**Report No:** WIR-024909**Date Inspected:** 18-Jun-2011**Project Name:** SAS Superstructure**OSM Arrival Time:** 1500**Prime Contractor:** American Bridge/Fluor Enterprises, a JV**OSM Departure Time:** 300**Contractor:** Zhenhua Port Machinery Company, Ltd (ZPMC), Changxing Island **Location:** Shanghai, China**CWI Name:****CWI Present:****Yes No****Inspected CWI report:** **Yes No N/A****Rod Oven in Use:** **Yes No N/A****Electrode to specification:** **Yes No N/A****Weld Procedures Followed:** **Yes No N/A****Qualified Welders:** **Yes No N/A****Verified Joint Fit-up:** **Yes No N/A****Approved Drawings:** **Yes No N/A****Approved WPS:** **Yes No N/A****Delayed / Cancelled:** **Yes No N/A****Bridge No:** 34-0006**Component:** OBG**Summary of Items Observed:**

Post Blast Inspection

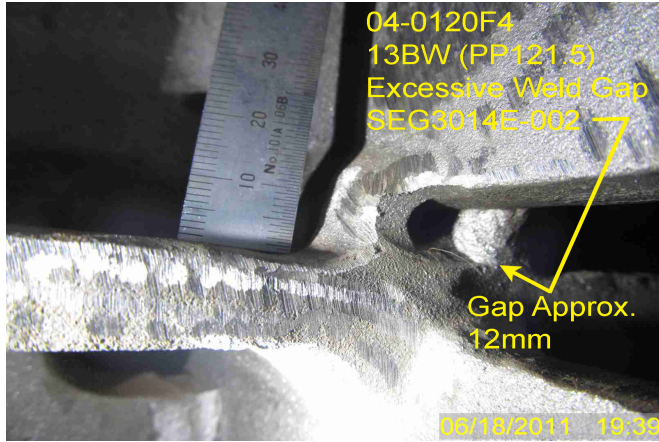
QA performed visual inspection (VT) of exterior welds/surfaces on OBG Segments 13AW, 13BW, PP119~PP12 CB side, Blast Shop 4. Caltrans QA observed excessive weld gap at 13BW, interior longitudinal diaphragm connection plate to floor beam flange at PP121.5 (East), weld SEG3014E-002 and missing weld at 13AW, interior deck plate stiffener to deck plate diaphragm at PP120 (CB side), weld SEG3013V-097. Caltrans QA informed ABF QC inspector Kelvin Cheung of the inspection results and informed him that a QA Incident Report is being generated for the excessive weld gap and missing weld. See QUALITY ASSURANCE – POST BLAST WELD REPAIR REPORT, dated 06-18-11 for additional information and Quality Assurance-Incident, dated 06-18-11 for further information.

The following digital pictures illustrate excessive weld gap.
